Emergency Response Plan

Leak Detection

Mark Hardison - Leak Detection Specialist III California Rural Water Association Critical Zone Leak Detection

Lake Francis Mutual Water Company PO Box 422 Dobbins Ca 95935 Ethel S Winchell - Board Memeber (530) 741-0820 / ethel@lakefrancisestates.org

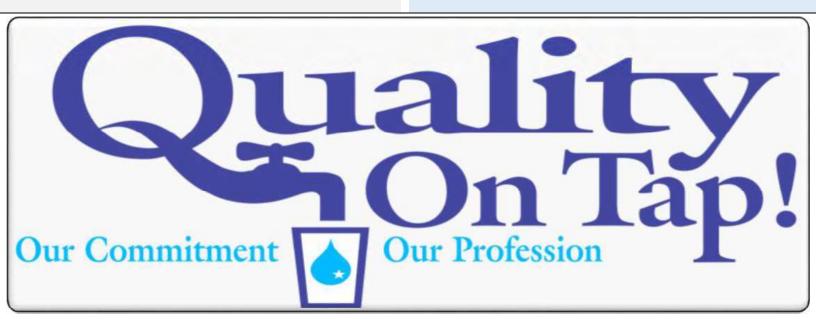
Leak	Report					
Date:			02/16/2022						
System:			Lake Francis M	lutual Water C	ompany				
Leak Detec	tion members:		M. Hardison						
Equipment	Used:		FCS Correlator	FCS Correlator/Acoustic Ground Mic/DXmic Pro Ground Mic					
Map Refer	on co.		Diamond Man	s/Coogle/CDS	/CIS Man				
wiap Keier	ence.		ріапіони імар	s/Google/GPS	/GIS IVIAP				
Street and	or Block Numbers:								
hirley Drive	e/Ingersoll Drive								
			ı						
Leak Number	Address of Suspected Leak	Utility or Customer (U or C)	Leak Pinpointed (Y or N)	Leak to be Rechecked (Y or N)	Leak Repaired (Y or N)	Comment			
1	Kenneth/Ingersoll	U	Y	N	N	Leaking Wharf Head			
	I I								
		Meters / Corp Stop	Hydrants	Valves	Test Rods	Other			
Indicate Number of Manual Listening Points Used		5	0	0	N/A				
	mber of Leak Noise ening Points Used	0	0	0	0	N/A			
			1	1	1

Meters / Corp Stop	Hydrants	Valves	Test Rods	Other	
Indicate Number of Manual Listening Points Used	13	5	0	0	N/A	
Indicate Number of Leak Noise Loggers Listening Points Used	0	0	0	0	N/A	
Miles of Mains Surveyed:	0.3	36	Survey Time	e: (Hours)	4.0	
Number of Leaks Suspected:		l	Rechecked:	(Numbers)	0	
Number of Leaks Pinpointed: 1			Pinpointing	Time: (Hours)	0.25	
Remarks:						
Leaking Wharf Head at Ingersoll Dr/Kenneth Ave. discovered during visual inspection on survey #4. See photo of leaking

Wharf Head on page 11.

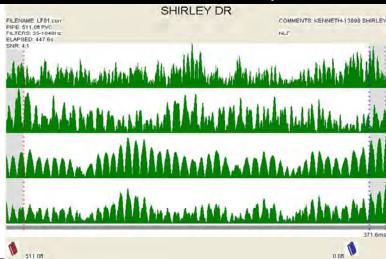
The Correlator program allows for a "**Snapshot Option**". When the snapshot button is pressed during a correlation, the snapshot feature effectively enables the operator to compare noise levels at different points during the correlation process. When a leak is detected, the graph will have a peak in the same spot and will be located in the same spot on all snapshots. This will indicate the presence of a leak.

Remarks:	Hydrant	2
No leaks were found during this survey.	Valve	
	Corp Stop	
	Diameter	4"
<u>Location:</u>	Material	PVC
Wharf Head at Kenneth Ave/Shirley Dr. to Wharf Head at 13898 Shirley Dr.	Length	511'

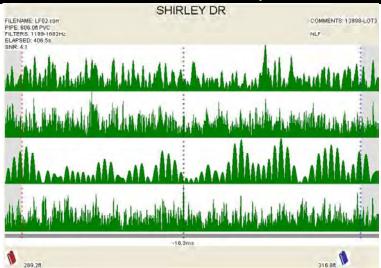
Survey #2

The Correlator program snapshots all differ in graph peaks, this indicates flow due to pumping, pressure surges or momentary use of water through meter(s).

The correlation has detected "No leak(s)".

Remarks:	Hydrant	2
No leaks were found during this survey.	Valve	
	Corp stop	
	Diameter	4"
Location:	Material	PVC
Wharf Head at 13898 Shirley Dr. to Wharf head at Lot#3 on Shirley Dr.	Length	606'

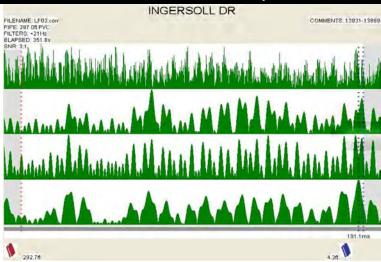
Survey #3

Remarks:	Hydrant 1
No leaks were found during this survey.	Valve
	Corp Stop 1
	Diameter 4"
<u>Location:</u>	Material PVC
Meter at 13931 Ingersoll Dr. to Wharf head at 13889 Ingersoll Dr.	Length 297'

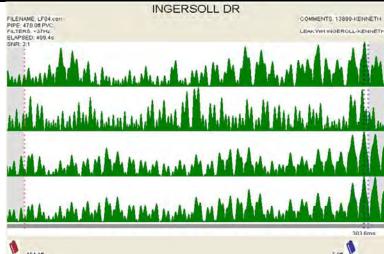
Leaking Wharf Head at Ingersoll Dr/Kenneth Ave. discovered during visual inspection on survey #4. See photo of _
leaking Wharf-Head on page 11. No additional leaks were found during this survey.

Wharf head at 13889 Ingersoll Dr. to Wharf head at Ingersoll Dr/Kenneth Ave.

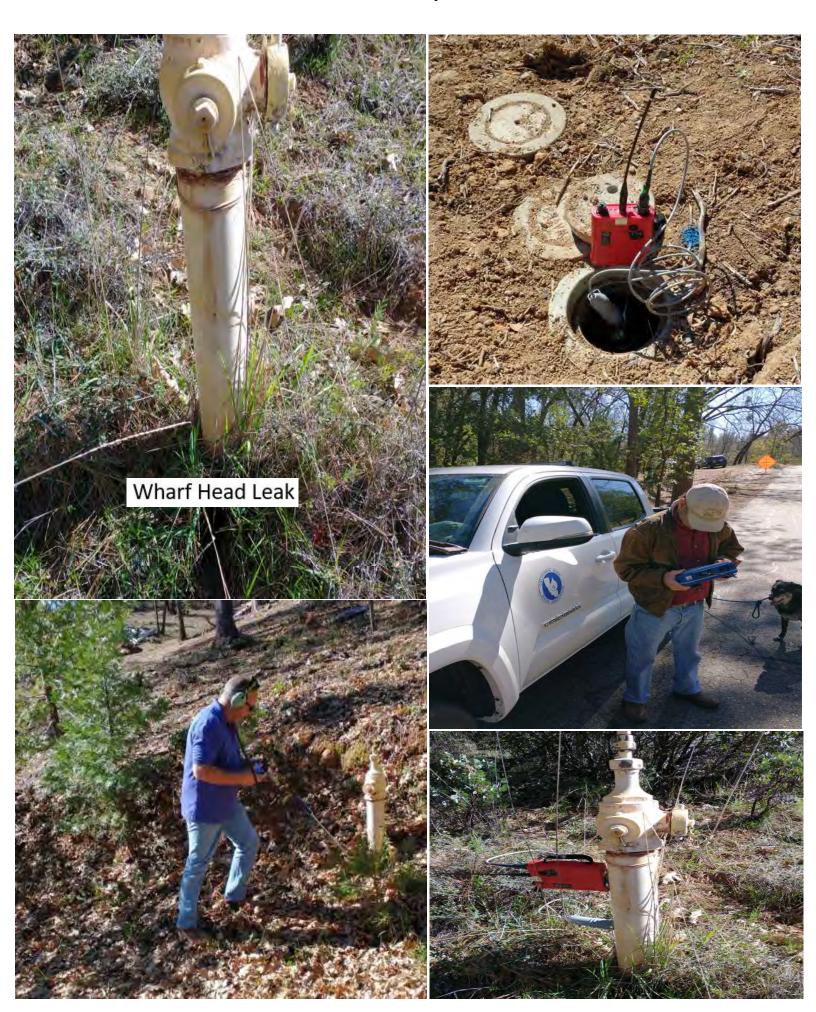
CRWA Survey Pictures

Address	/4	leter 1	alue H	ydrani.	mart He	and Pir	e Notes
Kenneth/Shirley				\checkmark			
13898 Shirley Dr	\			\checkmark			
13882 Shirley Dr	✓						
13908 Shirley Dr	✓						
Lot #3 Shirley Dr	\			✓			
13931 Ingersoll Dr	>						
Lot #5 Ingersoll Dr	>						
Lot #6 Ingersoll Dr	\						
Lot #34 Ingersoll Dr	>						
Lot #35 Ingersoll Dr	>						
13889 Ingersoll Dr	>			\checkmark			
13931 Ingersoll Dr	>						
13886 Ingersoll Dr	>						
Lot #11 Ingersoll Dr	>						
Kenneth/Ingersoll				\checkmark		V	Leaking from Wharf Head
